# UNDERWATER FACILITIES INSPECTIONS & ASSESSMENTS

UNDERWATER FACILITIES  
INSPECTION AND ASSESSMENT  
AT

NAVAL WEAPONS STATION  
CONCORD,  
CALIFORNIA

May, 1983

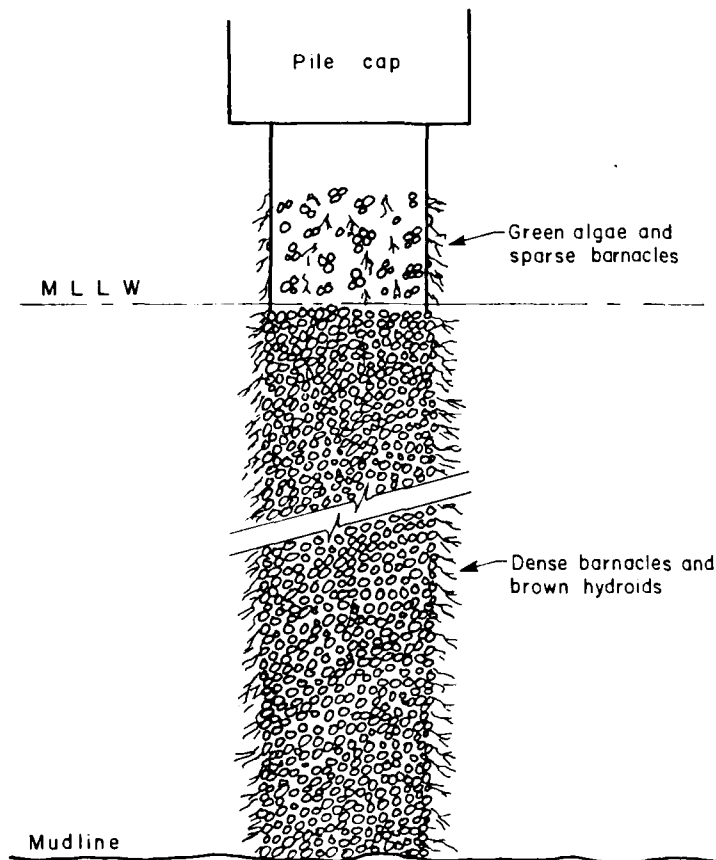
<b>J. Agi &amp; Associates Co. Ltd.</b> Suite 600, 1414 Alaskan Way, Seattle, WA		CHES DIV NAV FAC ENG COM	
		<b>MARINE GROWTH PROFILE</b> NAVAL WEAPONS STATION CONCORD, CA	<b>Fig.</b> <b>1</b>
Not to scale	June 1, 1983

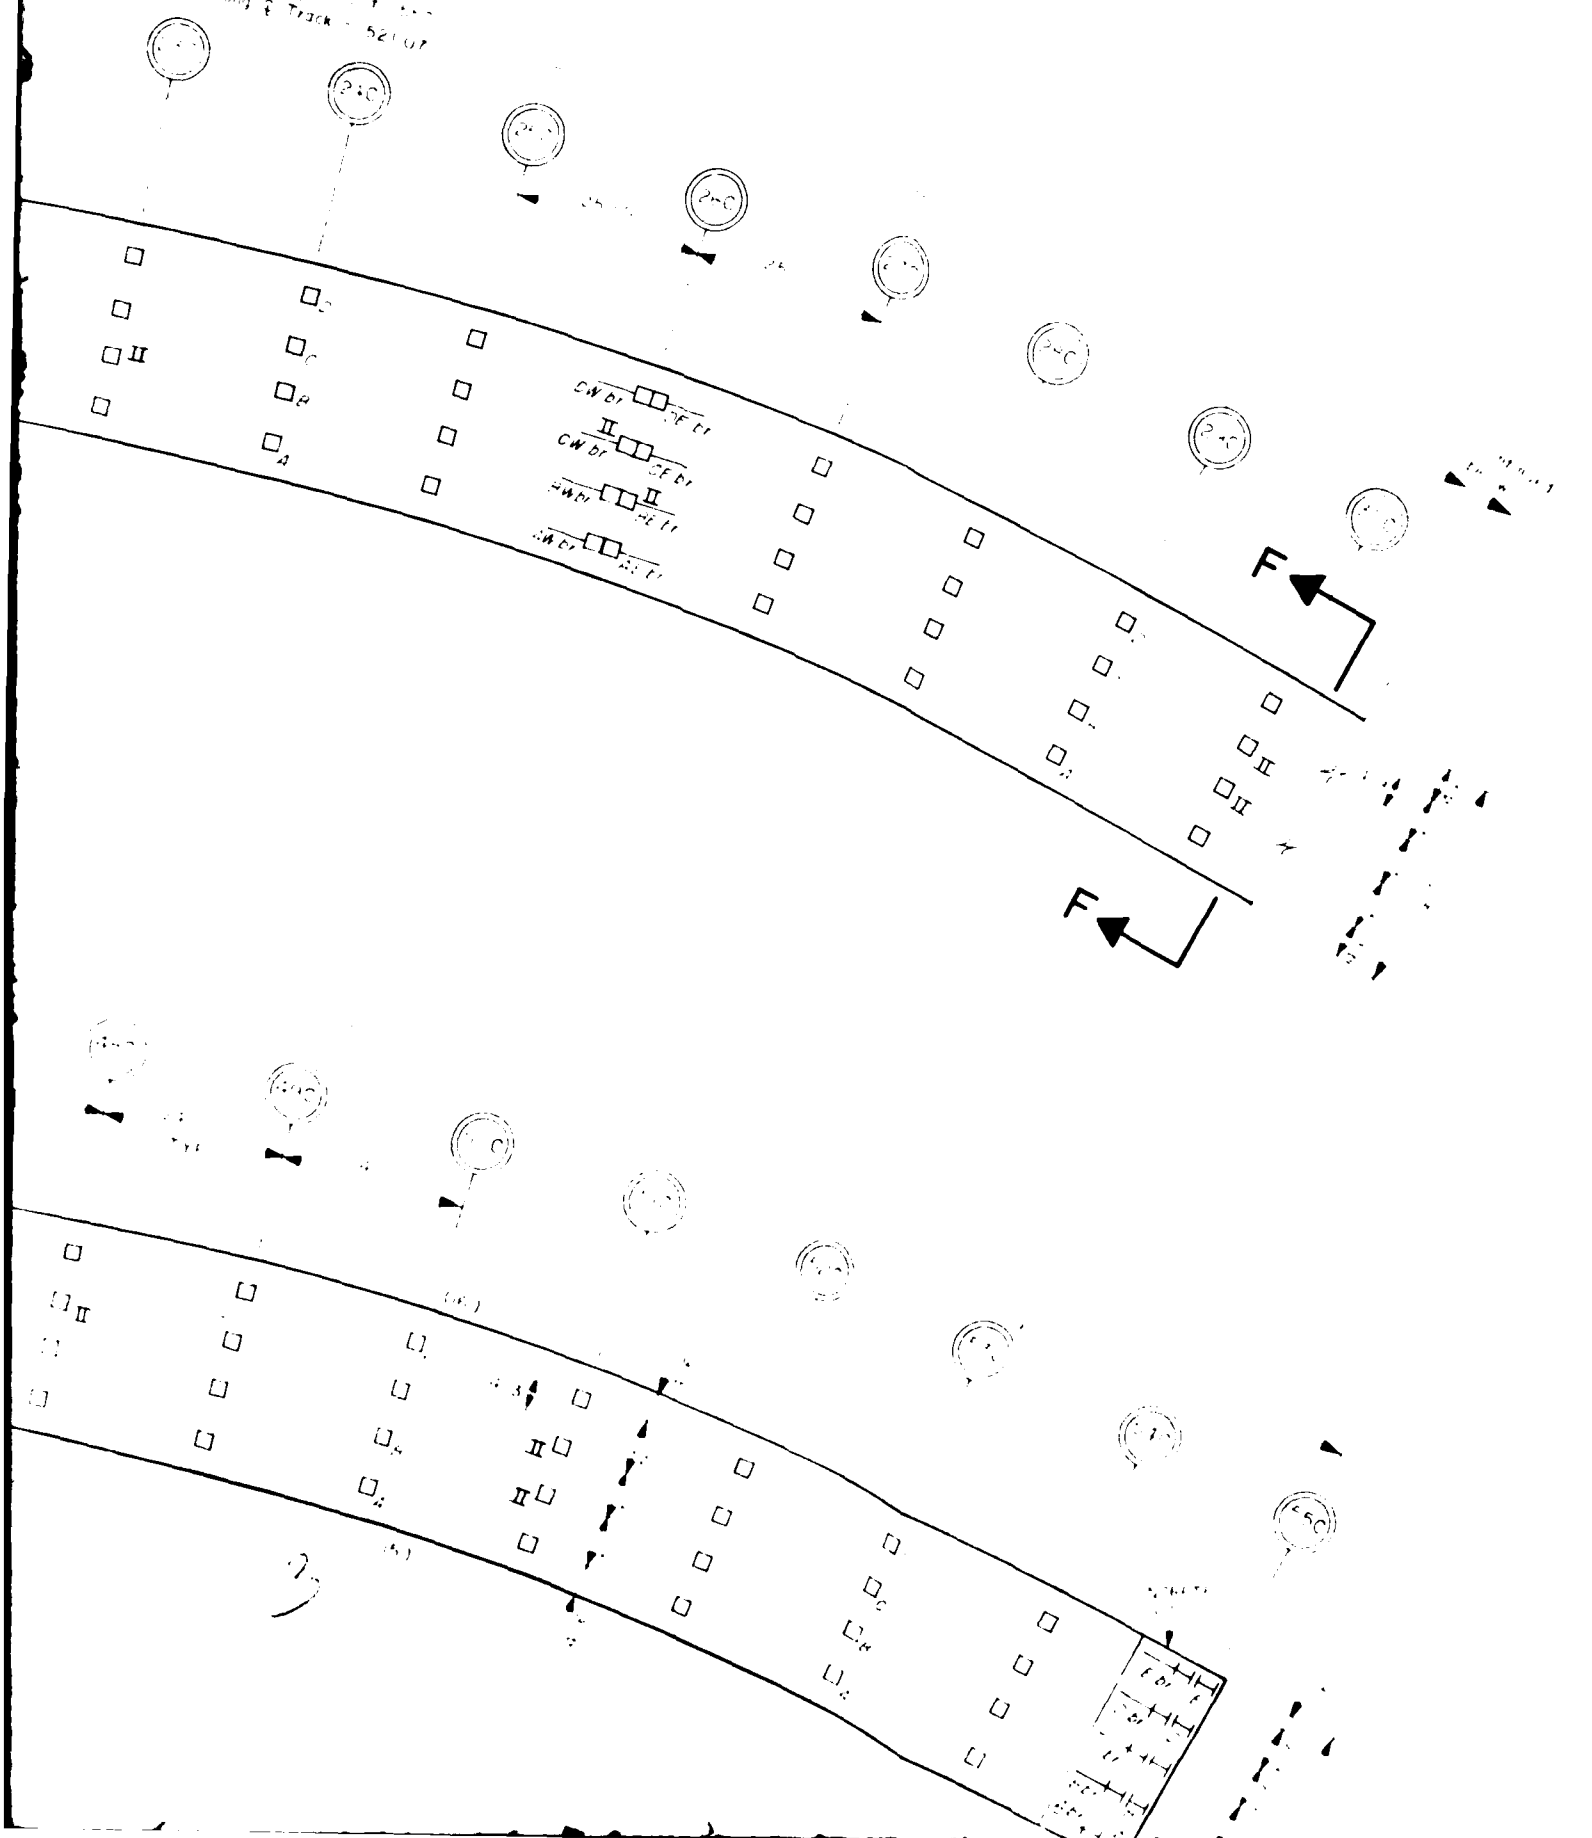
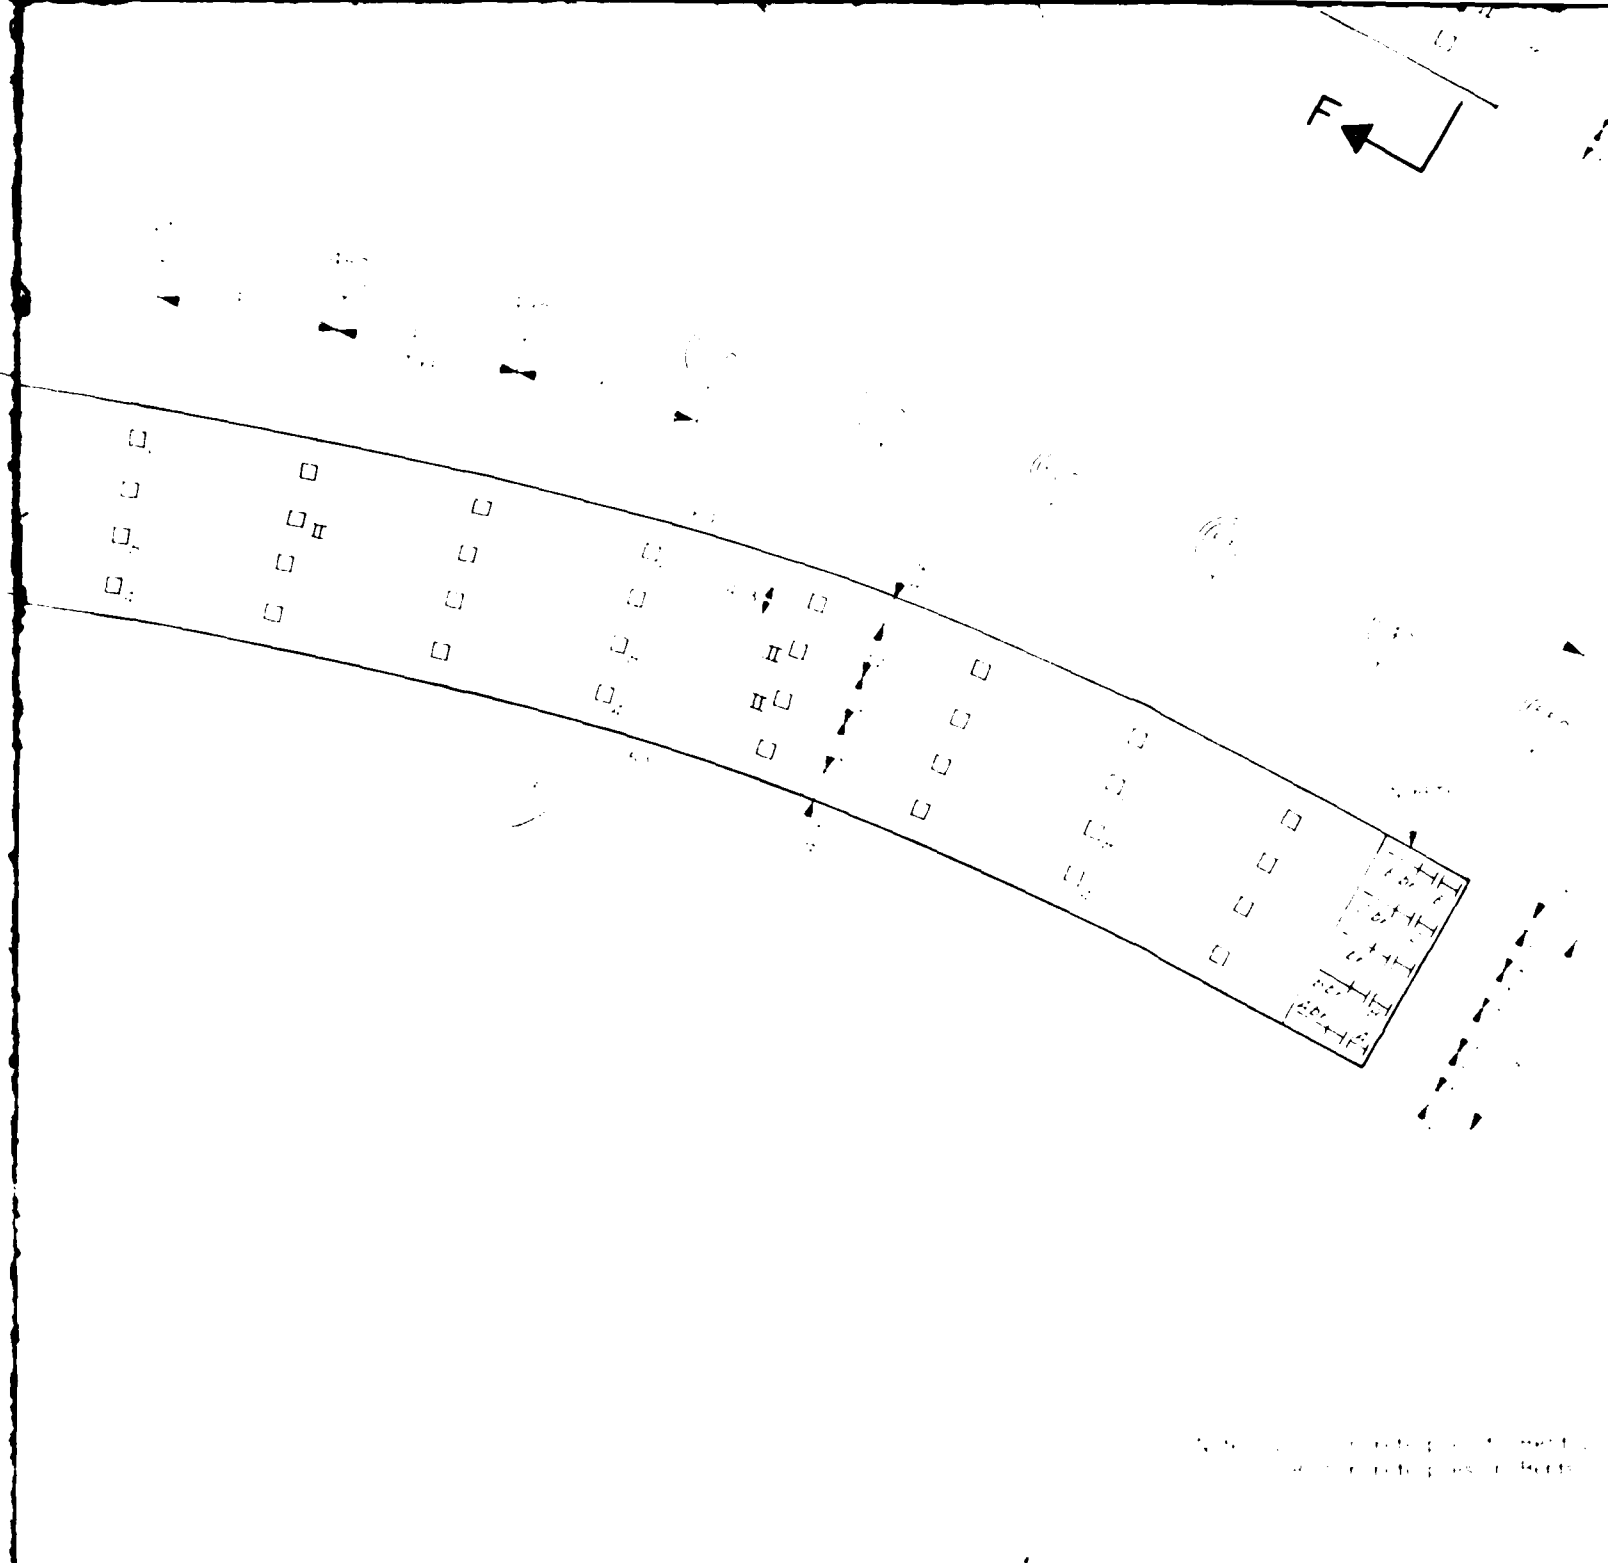
**DWG. No. 5**

PLAN SHOWING LOCATION  
AND CONDITION OF INSPECTED  
PIER 3, CONCRETE TREES  
U.S. NAVAL WEAPONS STATION  
CONCORD, CALIFORNIA

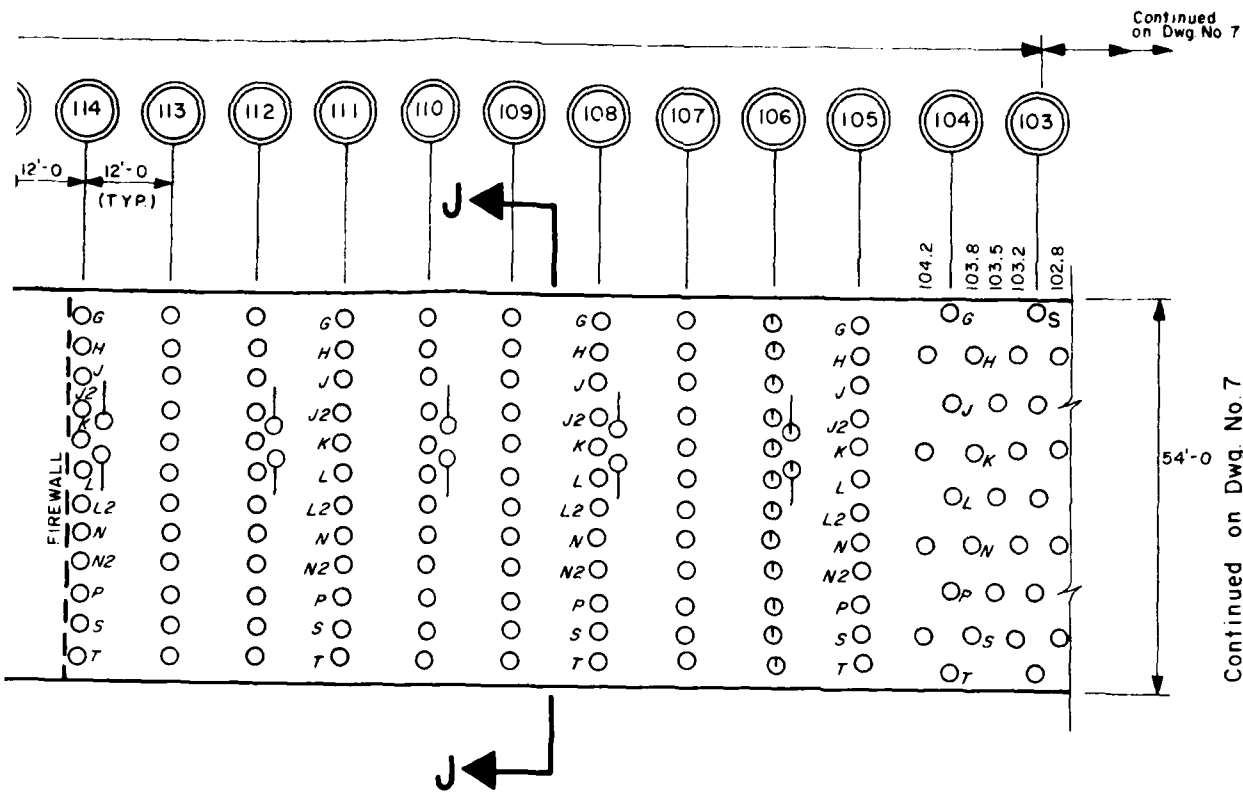
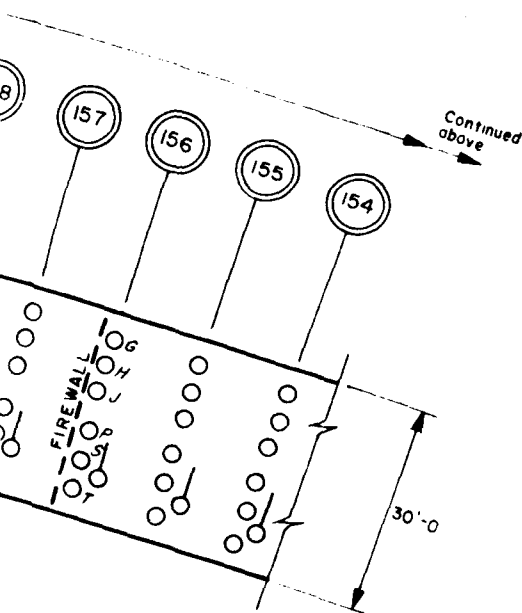
PLAN SHOWING LOCATION  
AND CONDITION OF INSPECTED PILING IN  
PIER 4, PIERHEAD  
U.S. NAVAL WEAPONS STATION  
CONCORD, CALIFORNIA

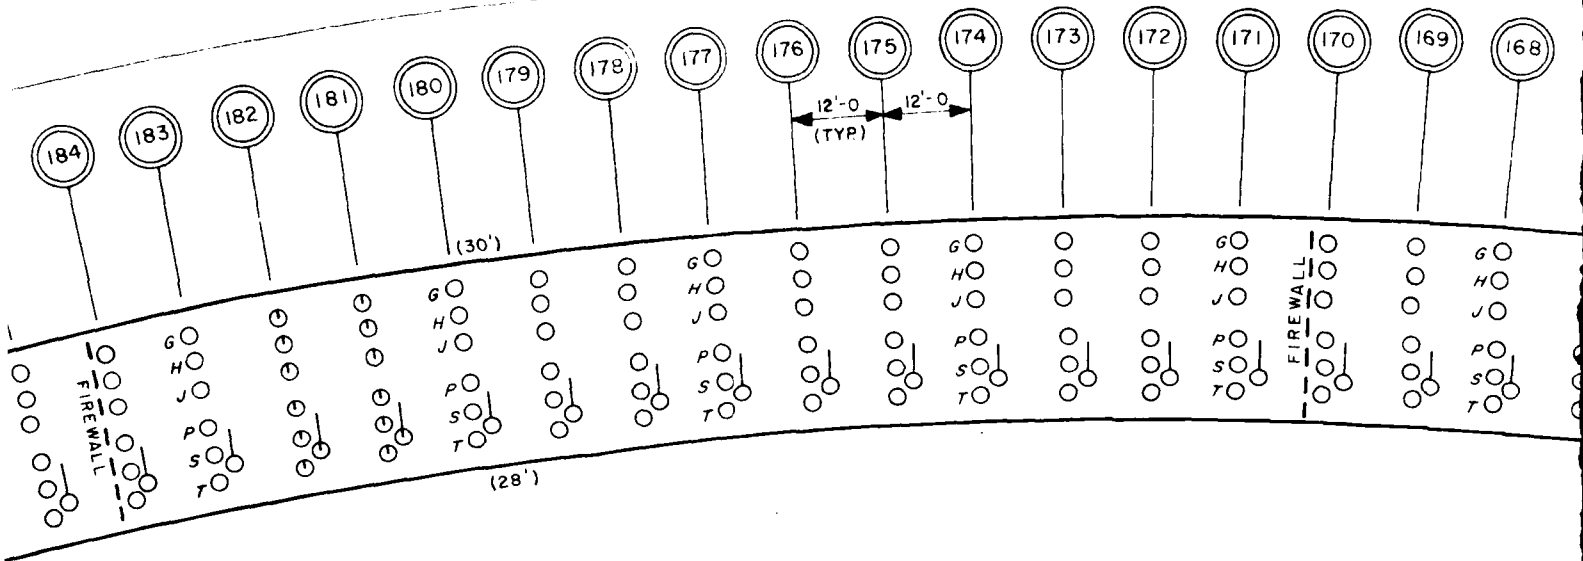
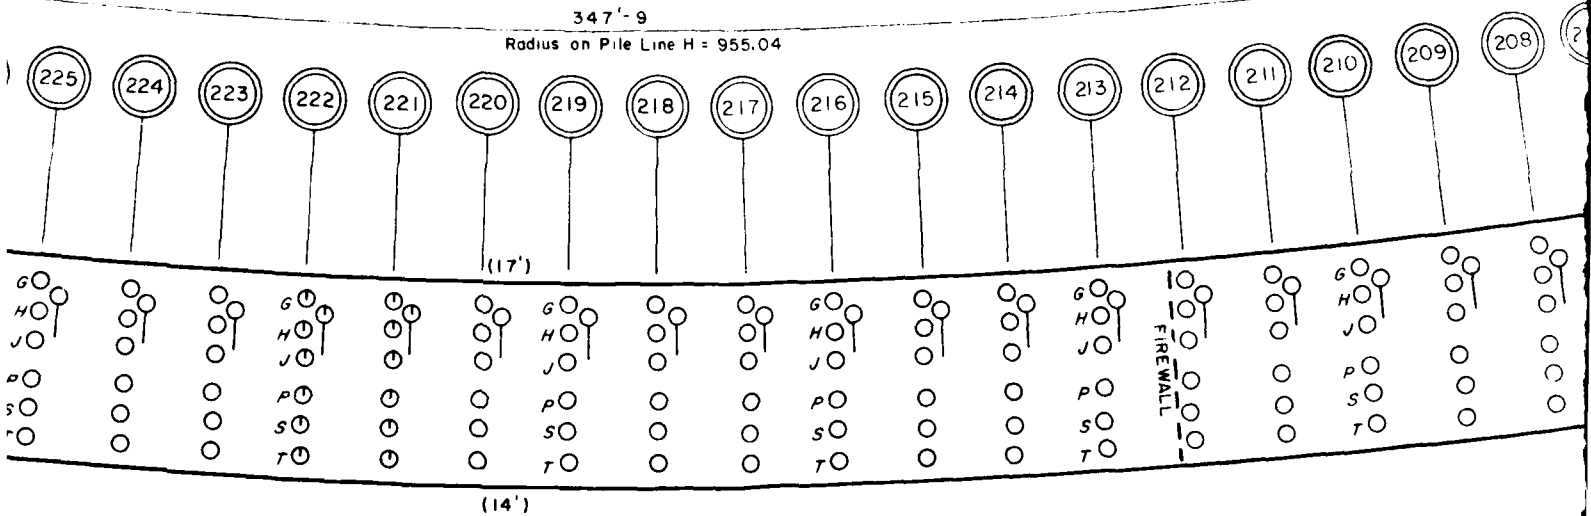
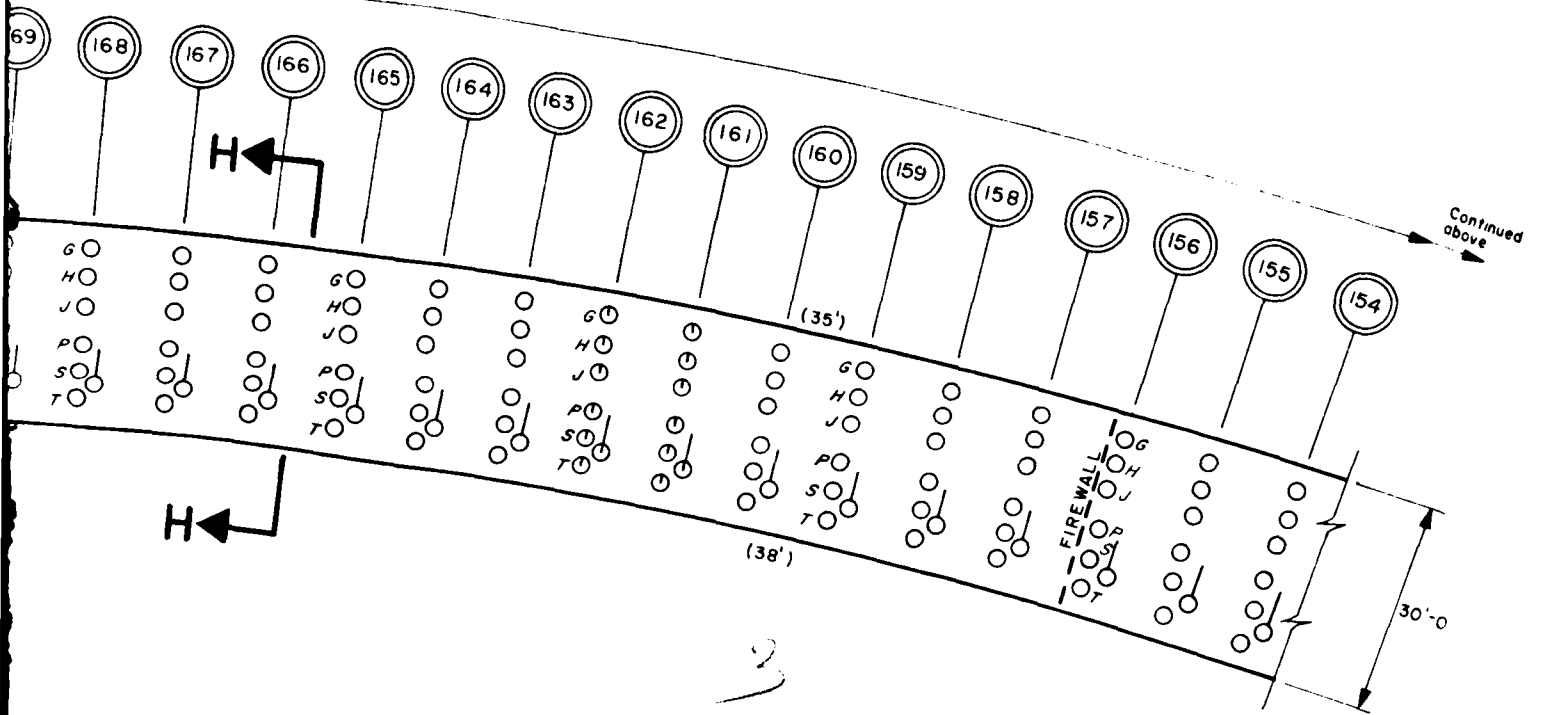
PLAN SHOWING LOCATION  
AND CONDITION OF INSPECTED PILING IN  
PIER 4, APPROACHWAY TRETTLE  
U.S. NAVAL WEAPONS STATION  
CONCORD, CALIFORNIA

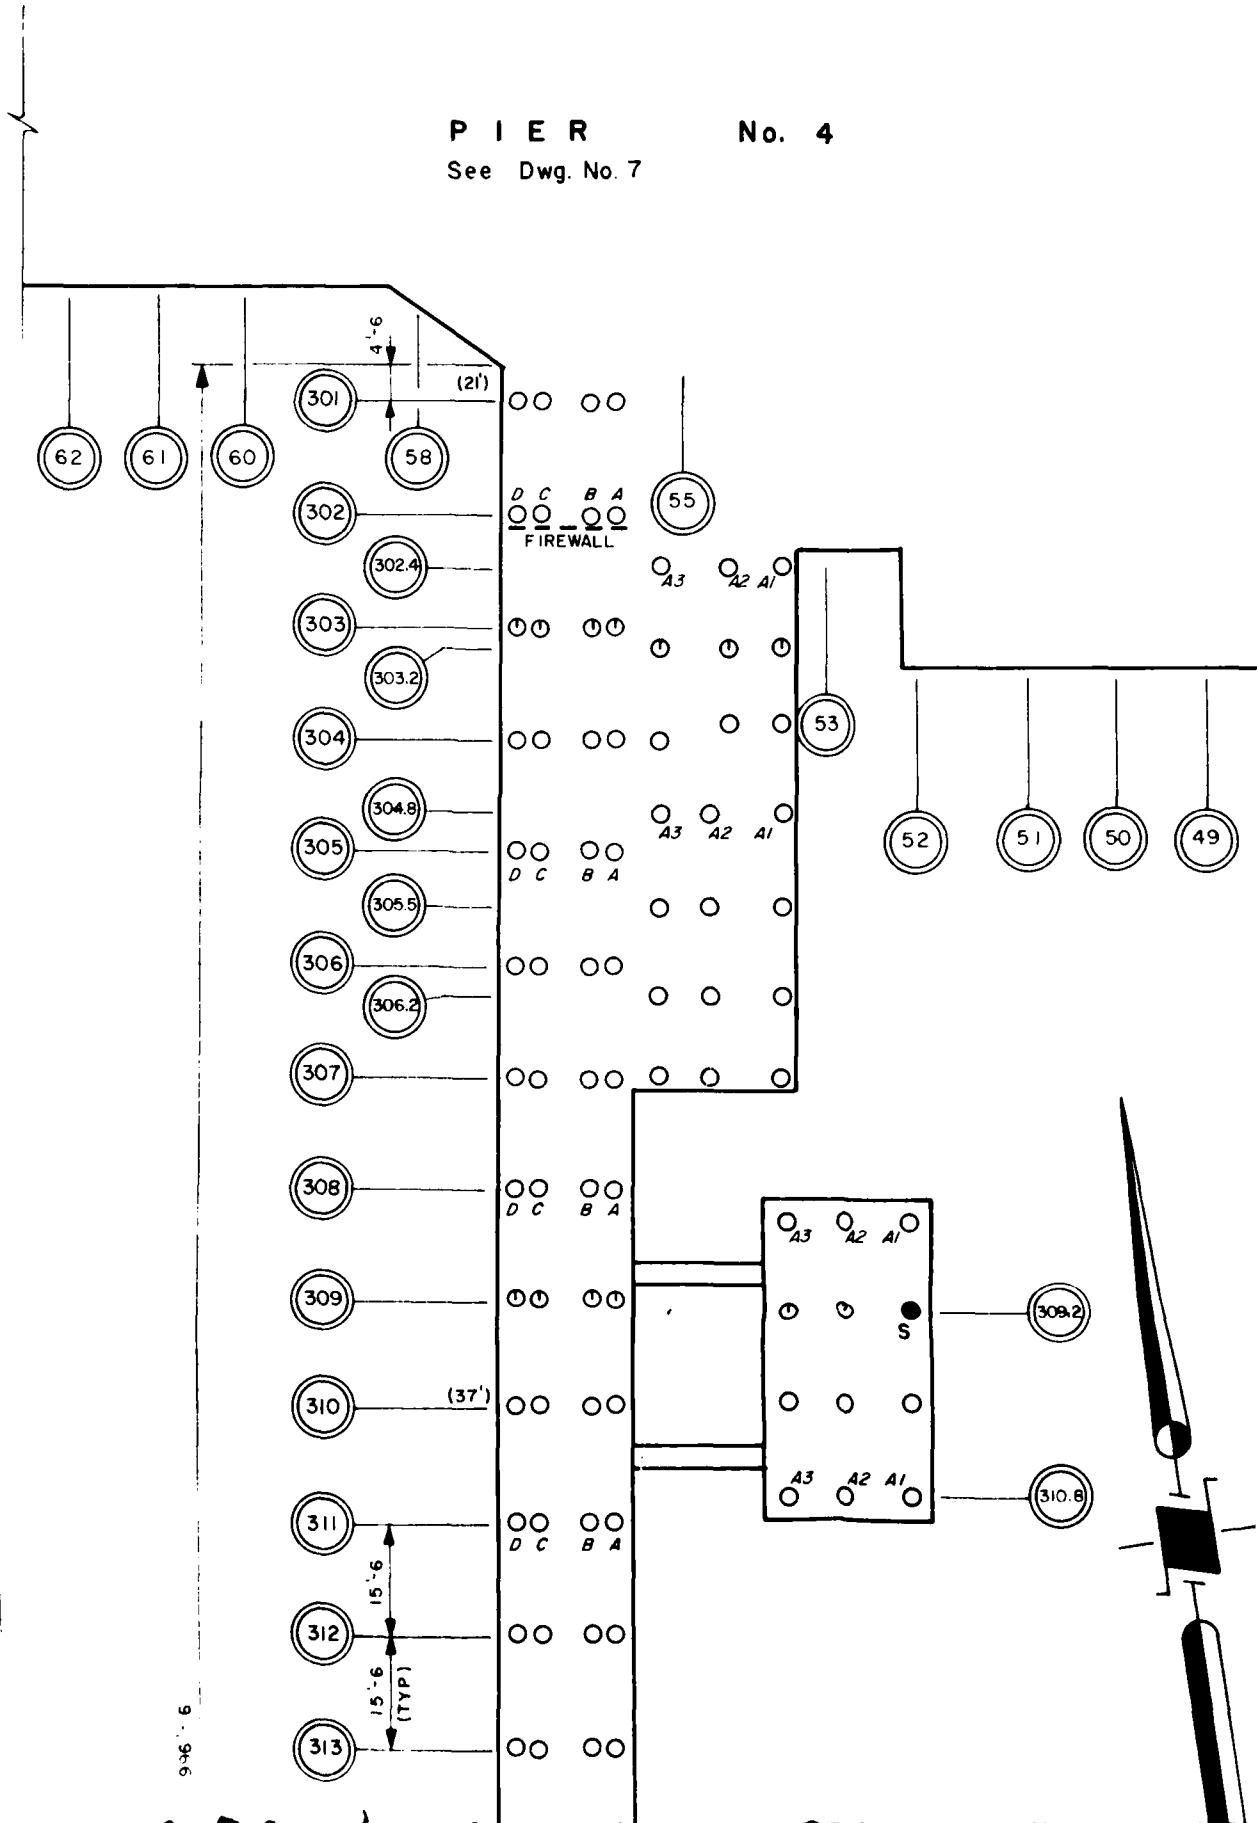
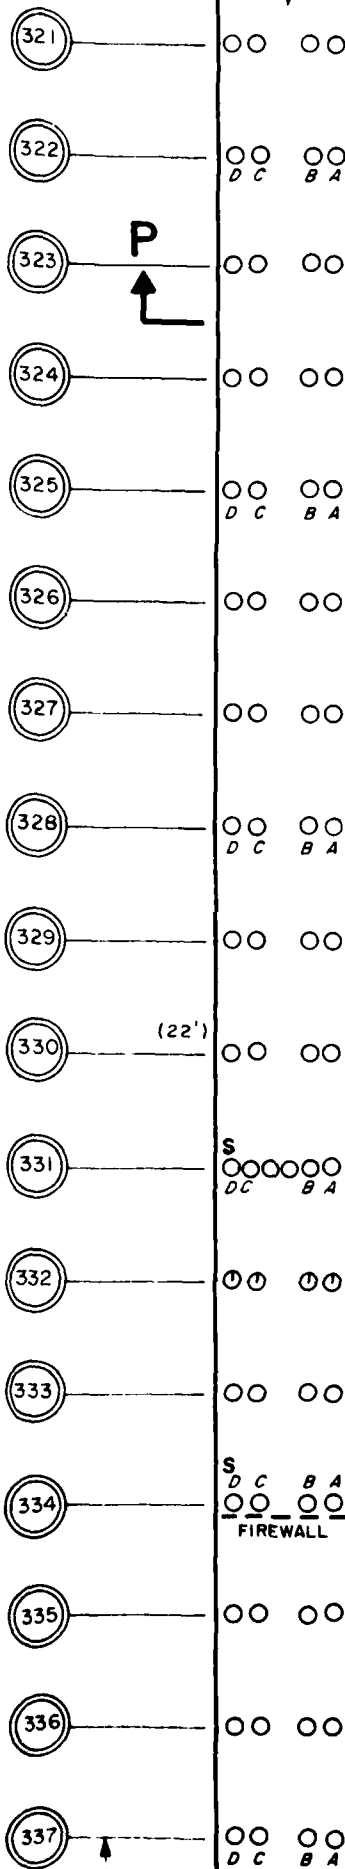
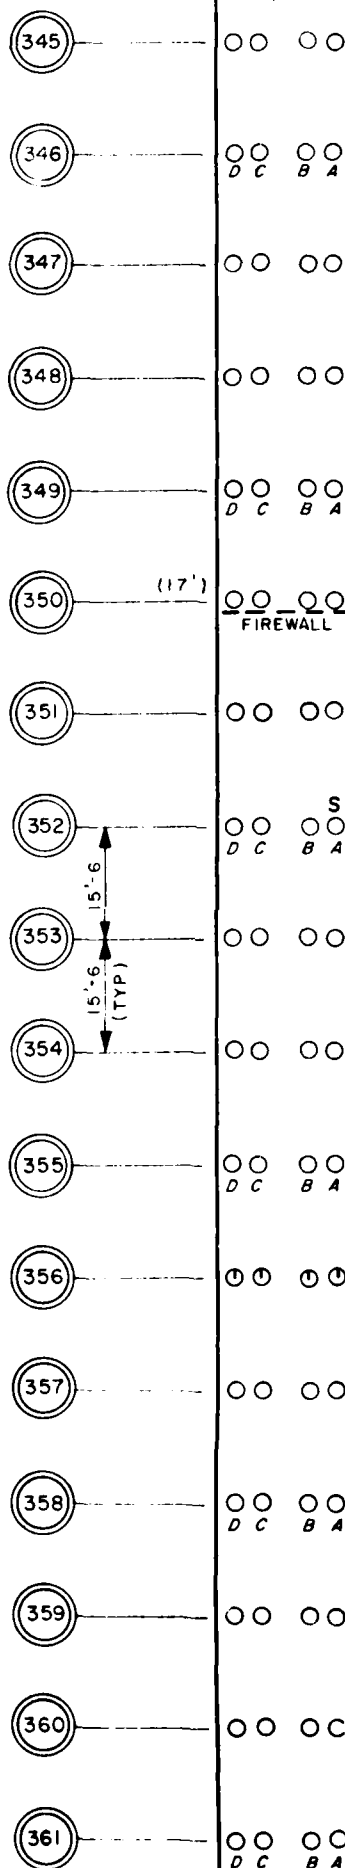
PLAN SHOWING LOCATION  
AND CONDITION OF INSPECTED PILING IN  
PIER 4, ACCESS TRESTLE  
U.S. NAVAL WEAPONS STATION  
CONCORD, CALIFORNIA

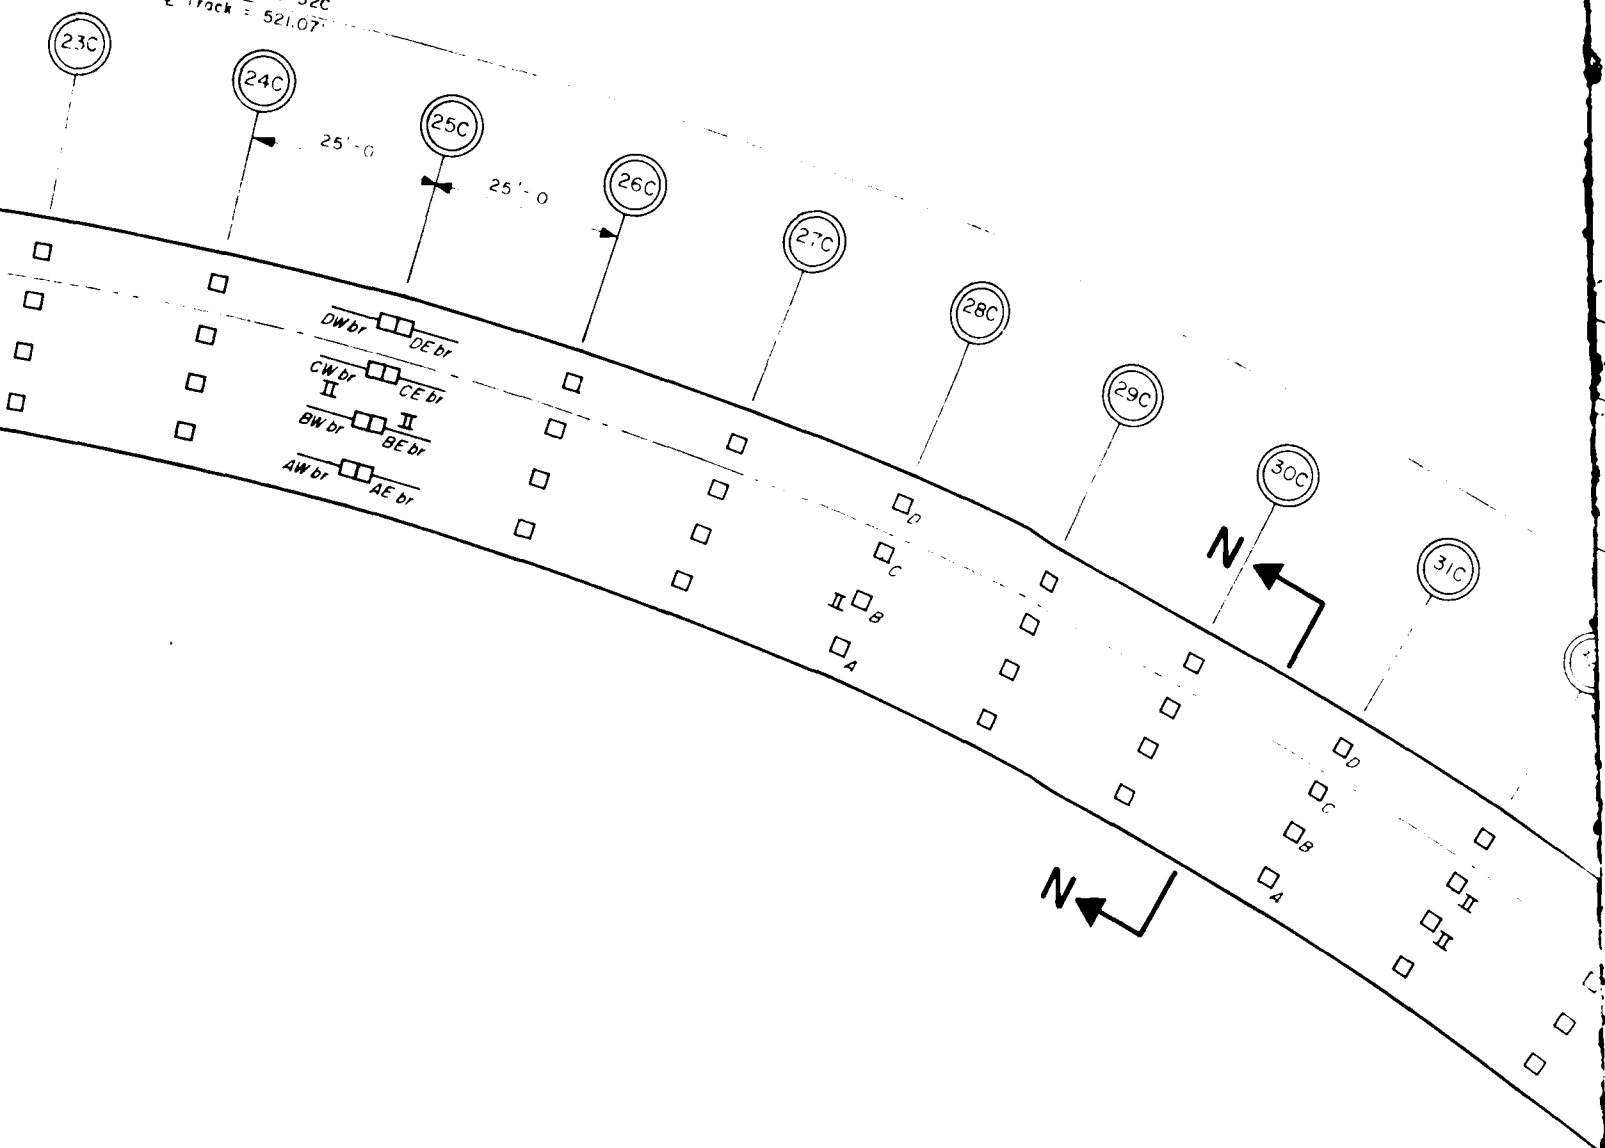
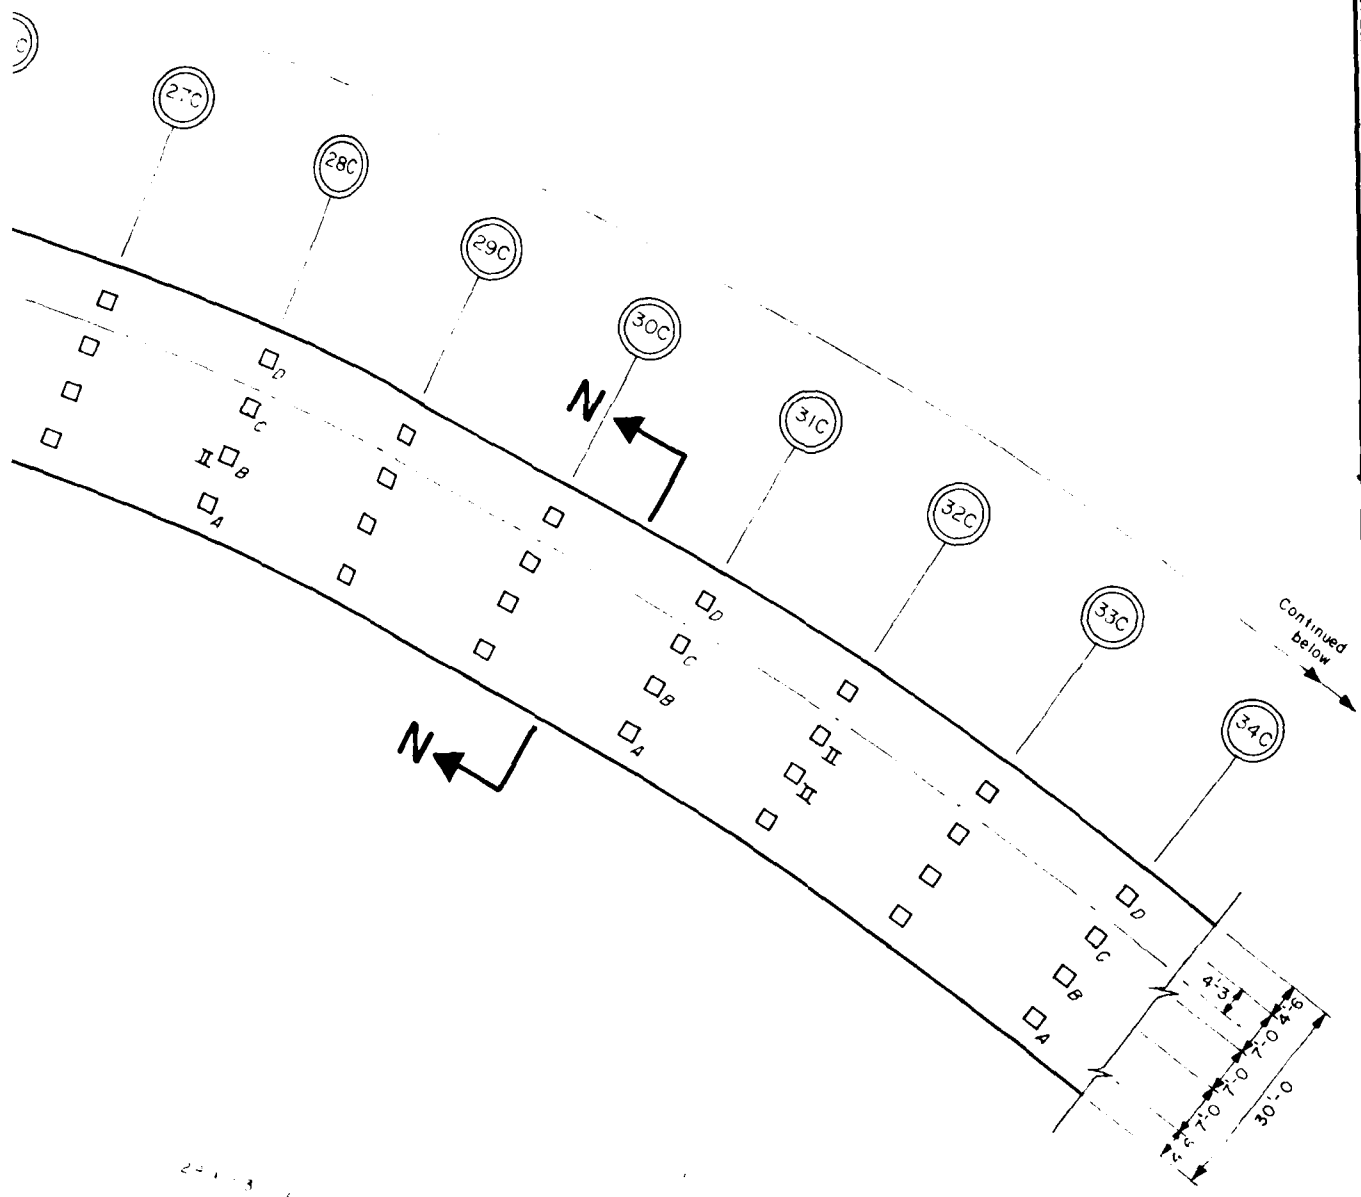
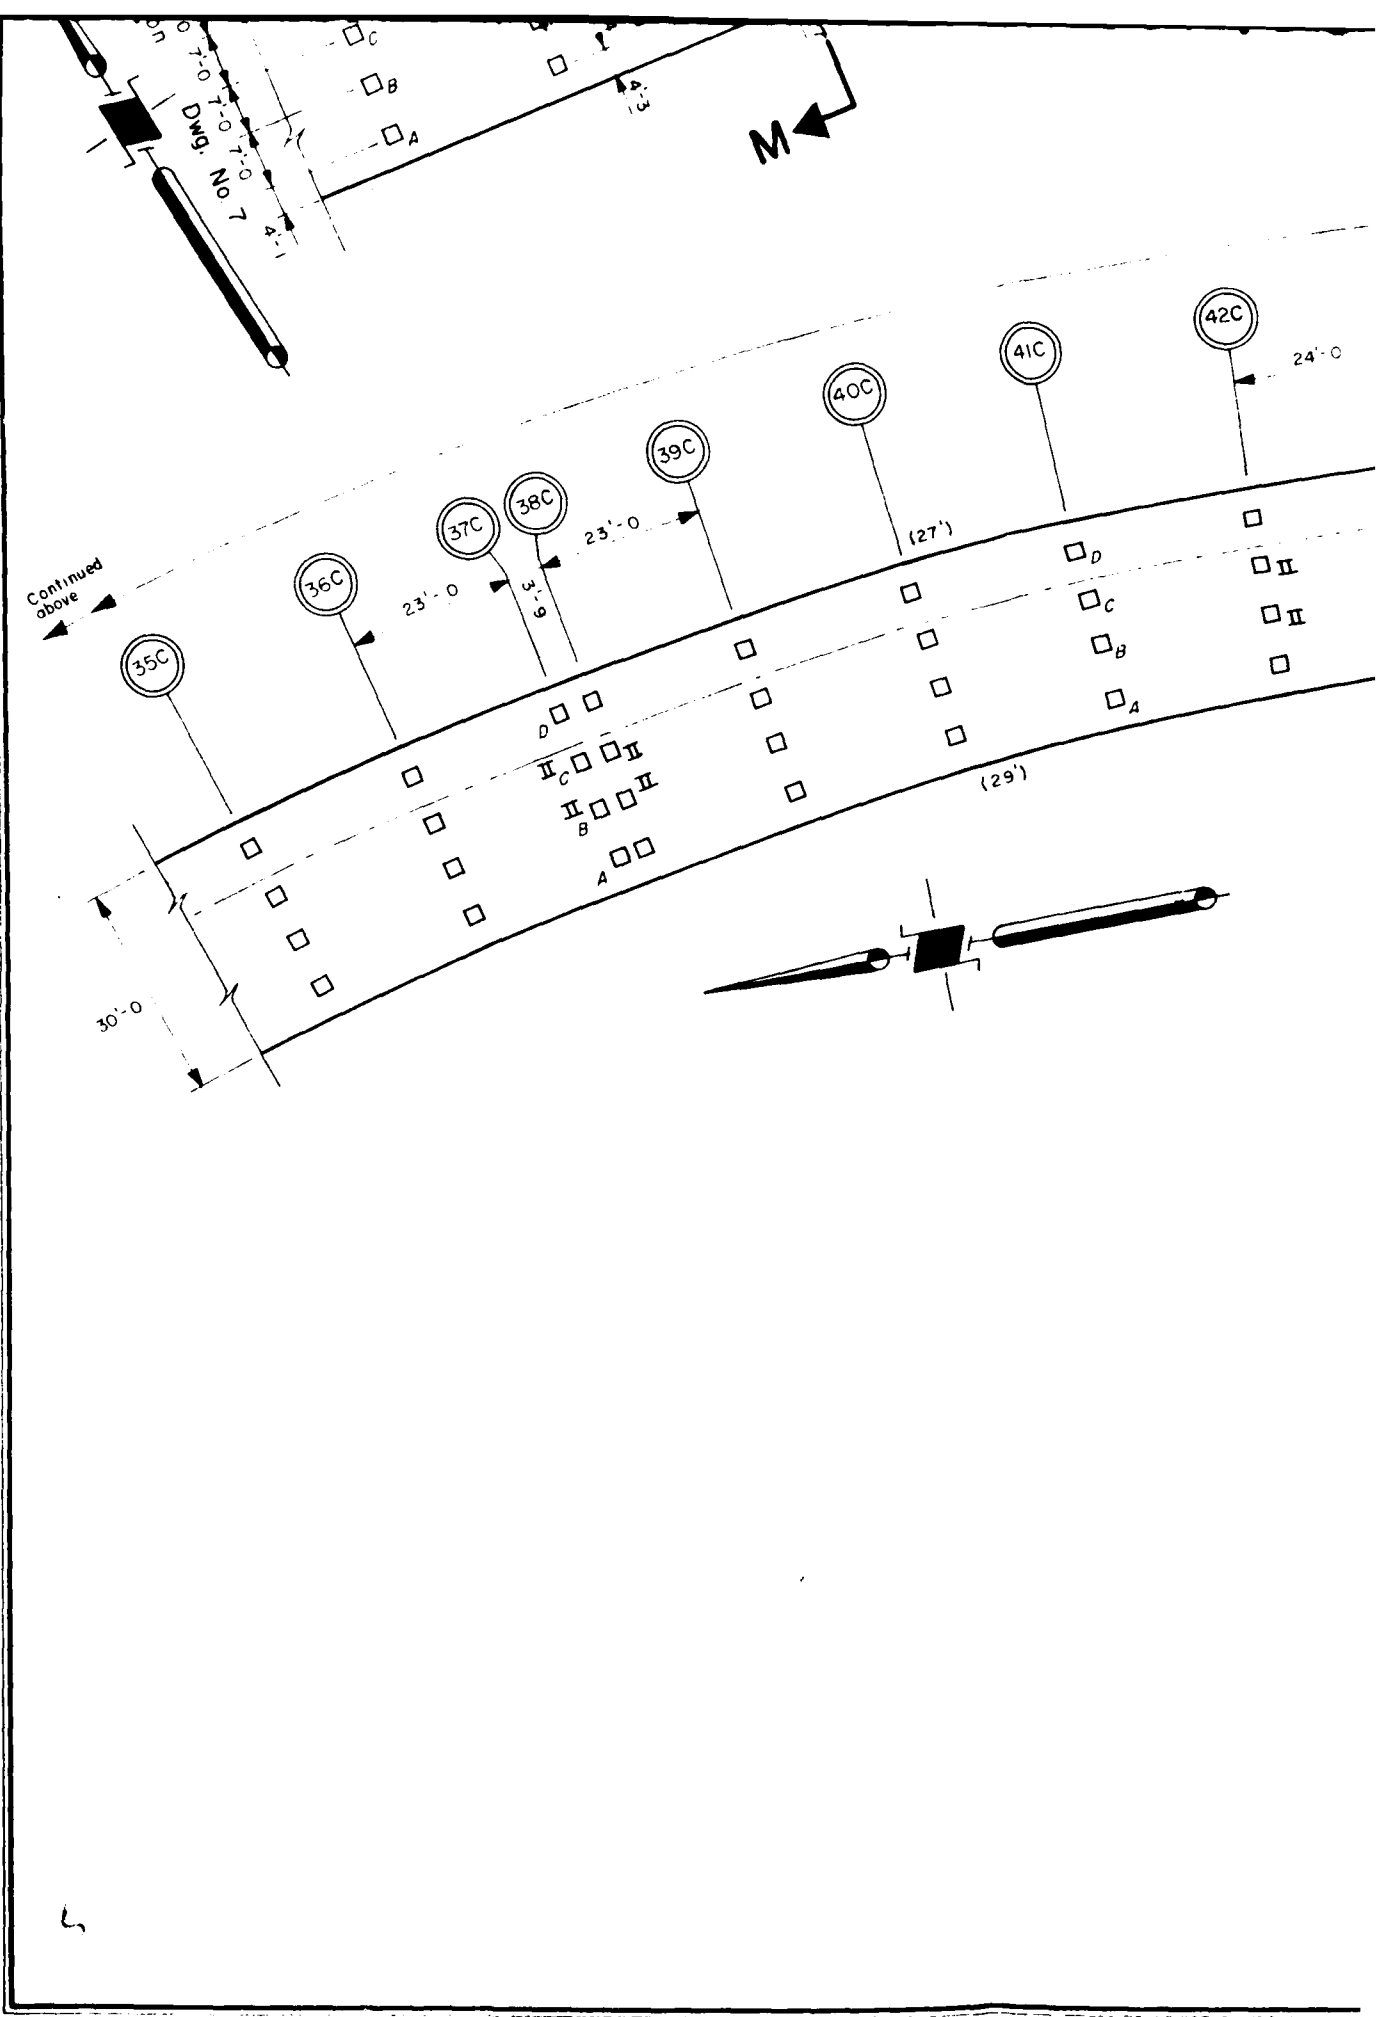
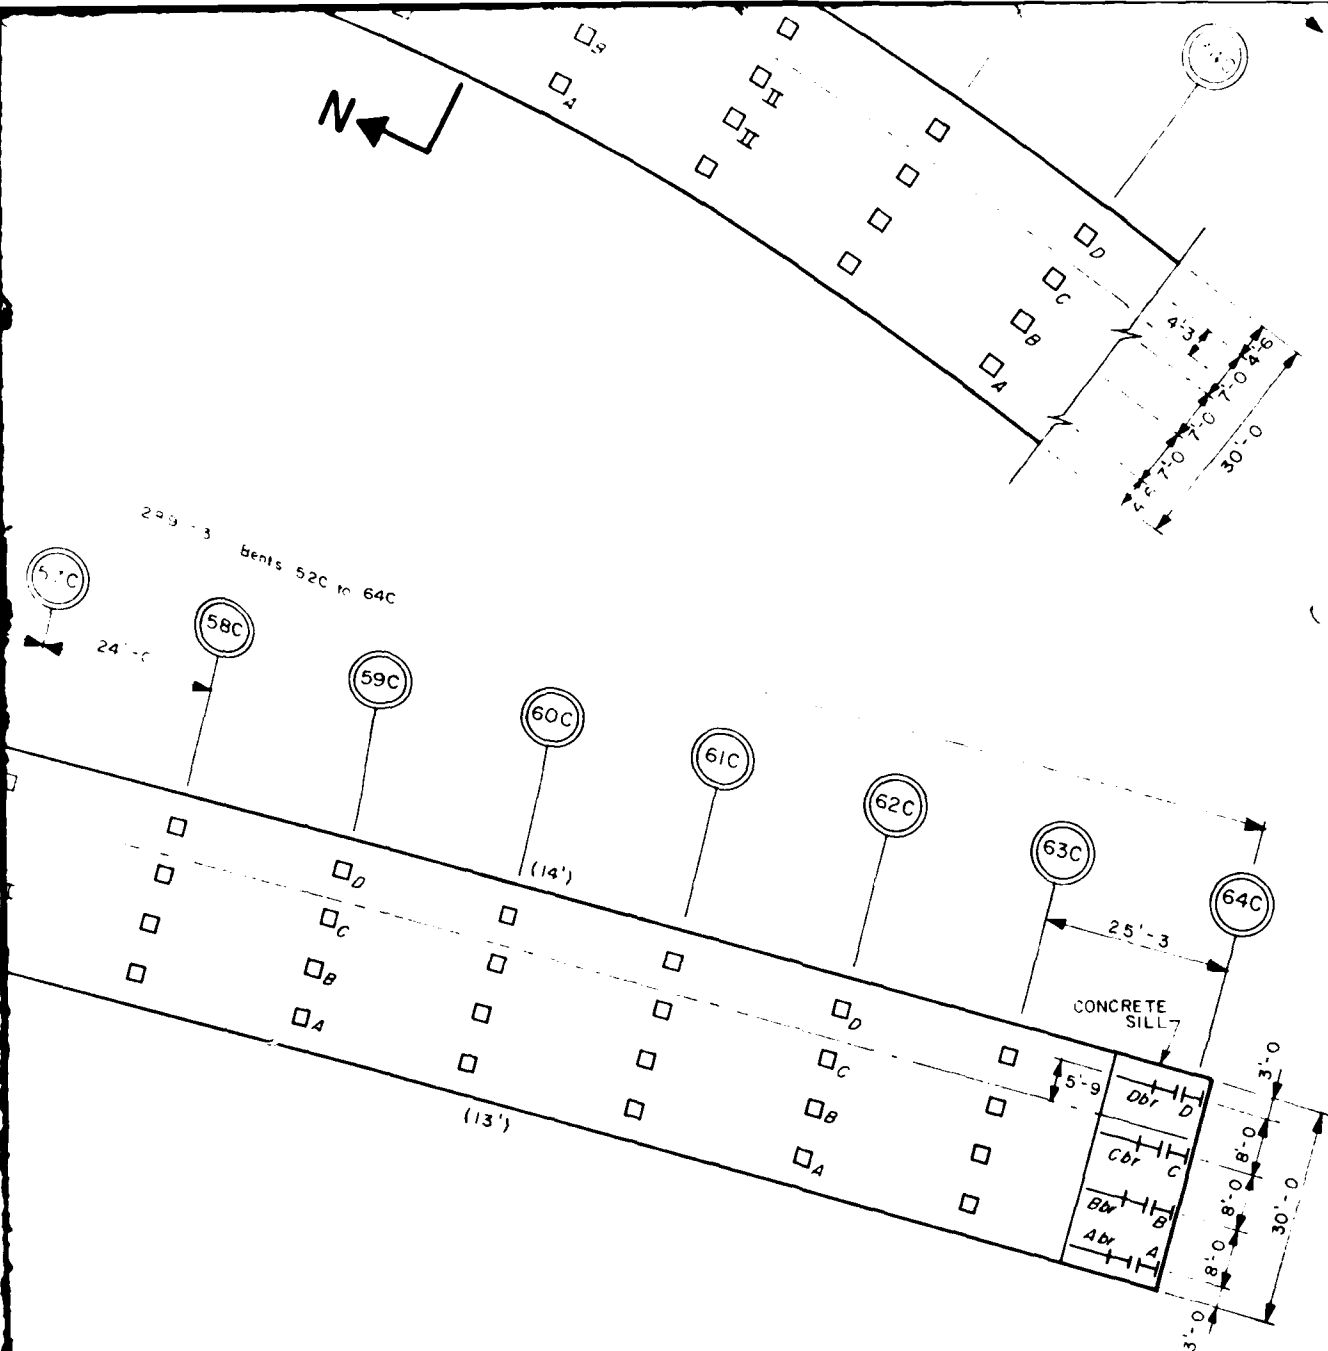
<b>J. AGI &amp; ASSOCIATES CO. LTD.</b> Suite 600, 1414 Alaskan Way, Seattle, WA		SCALE 1" = 20'
PLAN SHOWING LOCATION AND CONDITION OF INSPECTED PILING IN PIER 4, CONCRETE TRESTLE U.S. NAVAL WEAPONS STATION CONCORD, CALIFORNIA  CHES DIV NAV FAC ENG COM REPORT No. FPO-1-83-(19) CONTRACT No. N62477-81-C-0498 TASK 2 <b>DWG. No. 10</b>		DRAWN F P
		CHECKED <b>J.P.</b>
		APPROVED <b>XIE</b>
		DATE JUNE 7, 1983.
		PROJECT No <b>83-1/3-2-100</b>
